## DEPARTMENT OF ECOLOGY

MEMORANDUM October 7, 1980

Subject: Granite Falls Class II

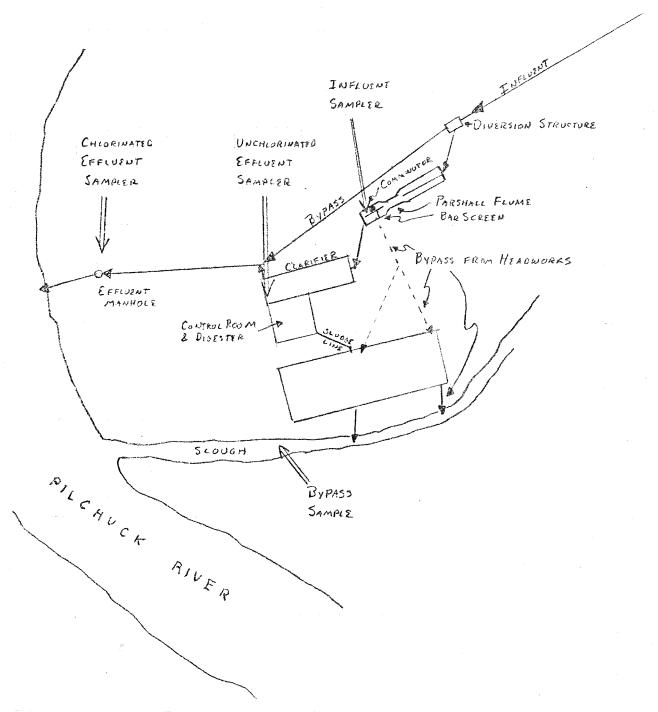
FIGURE 1. GRANITE FALLS STP AND SAMPLING LOCATIONS

The Granite Falls wastewater treatment plant is a conventional primary plant constructed in the late 1950's. Figure 1 shows the plant and sampling points. Points of design which deserve particular mention are the previously unknown bypass from the comminutor chamber to the sludge beds, the lack of continuous flow recording equipment at the plant, and an underground chlorine contact chamber which appears to be a pipe with a weir at the effluent manhole which keeps water backed up into the pipe. Dye tests indicated this contact chamber does not have an adequate detention time.

These composite samplers were placed as noted in Figure 1. Samples from these compositors are not perfectly representative of plant waste flows during the 24-hour inspection primarily due to an unusual plant bypass which occurred in the early morning hours of August 27, 1980 (between about 0130 and 0915). On arrival at the plant on the morning of August 27, no flow was passing through the plant. The comminutor was stopped and influent flow was disappearing from the comminutor chamber. Investigation revealed that the entire plant flow was bypassing (by way of underground piping) to the sludge bed and then to a small (previously dry) slough which drains to the Pilchuck River. A grab sample of this bypass was obtained from the slough.

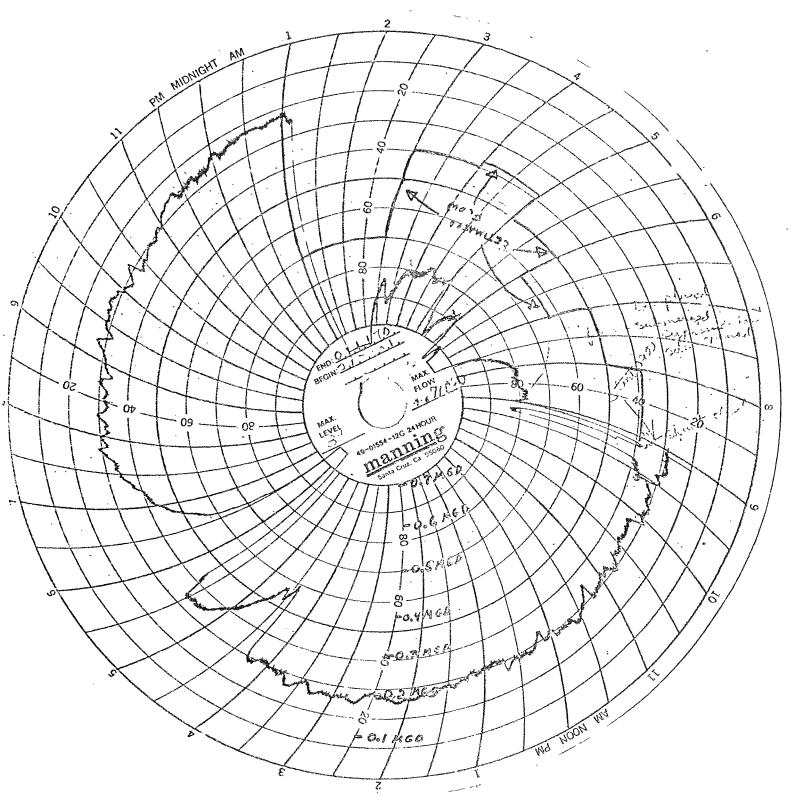
Flower 2. FLOW Scient CHART - 3/26-27/80

A Manning "dipper" flow meter and totalizer was placed at the Parshall flume to obtain a record of plant flow. The script chart from this meter is shown in Figure 2. Heavy rains occurred during the afternoon of August 25 and the early morning of August 27.

When Terry and Joe (plant operators) arrived, they went to work on the comminutor and removed a rat from the blades. The failure of the communitor also caused flow to back up into the Parshall flume, making part of the flow record inaccurate. The estimated flow line (Figure 2, 1 a.m. to 9 a.m.) was used in concert with the rest of the record to estimate 24-hour flow.
